Comparison of JET main chamber erosion with dust collected in the divertor

The following article appeared in Journal of Nuclear Materials, Vol.438, Supplement, July 2013, p.S827. Proceedings of the 20th International Conference on Plasma-Surface Interactions in Controlled Fusion Devices.

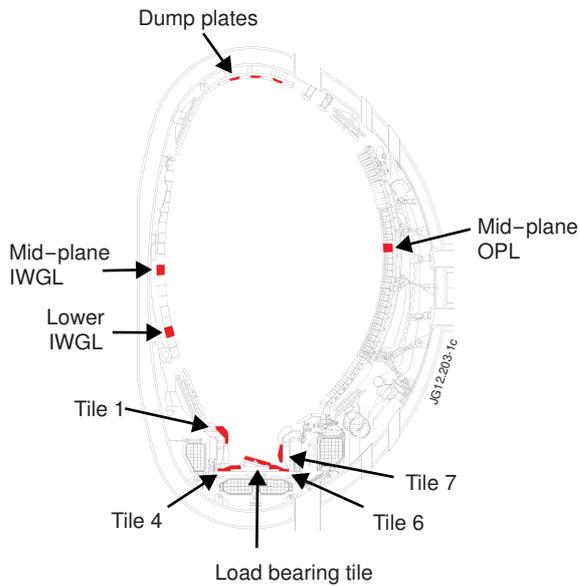
Figure 1 Poloidal cross section of the JET vessel with the MkII-HD divertor. The results presented in this paper are indicated and come from Tile 1, 4, Load Bearing Tile, Tile 6 and 7 in the divertor and tiles from the Inner Wall Guard Limiter, Dump Plate region and the Outer Poloidal Limiter in the main chamber. Inner Wall Cladding tiles are recessed behind the IWGL and fill the space between the sixteen IWGL beams.

The erosion and deposition of inner wall guard limiter (IWGL) tiles, outer poloidal limiter (OPL) tiles and dump plate tiles from the main chamber and tiles constituting a poloidal divertor cross section has been measured by profiling the surfaces of a set of tiles before and after exposure in the vessel. Figure 1 shows the poloidal location of the tiles analysed for this paper. Each IWGL location is made up from a pair of tiles; a left hand and a right hand tile (looking to the centre of the machine). Each OPL tile is a tile pair placed one

Figure 1 Poloidal cross section of the JET vessel with the MkII-HD divertor. The results presented in this paper are indicated and come from Tile 1, 4, Load Bearing Tile, Tile 6 and 7 in the divertor and tiles from the Inner Wall Guard Limiter, Dump Plate region and the Outer Poloidal Limiter in the main chamber. Inner Wall Cladding tiles are recessed behind the IWGL and fill the space between the sixteen IWGL beams.

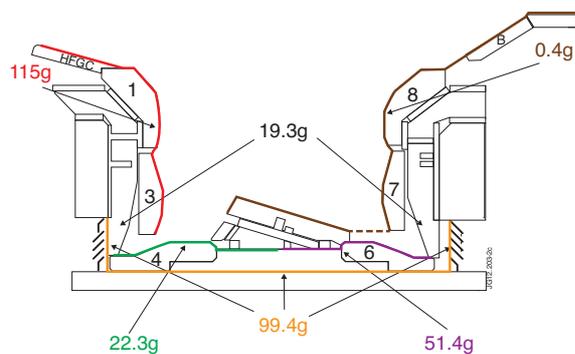
Figure 2 Cross section of Mk-HD divertor section showing the mass of dust/flakes vacuumated from different regions.

The masses of dust and flakes collected from the divertor region also contributes to the amount of carbon found in the divertor. The masses collected are shown in Figure 2. The largest amounts of dust collected were in the regions where significant deposition has taken place; notably at the inner divertor (115 g) where heavy deposition has been observed on the top horizontal surface of Tile 1s, from Tile 4s and Tile 6s (22 g and 51 g respectively) where thick deposits form on the sloping regions as shown in Figure 3(a) and also at the inner and outer louvres (91 g) remote from the plasma. In total the mass of dust/flakes collected after scaling for the areas surveyed and the vacuuming history of the tiles was 300 g.

Figure 2 Cross section of Mk-HD divertor section showing the mass of dust/flakes vacuumed from different regions.

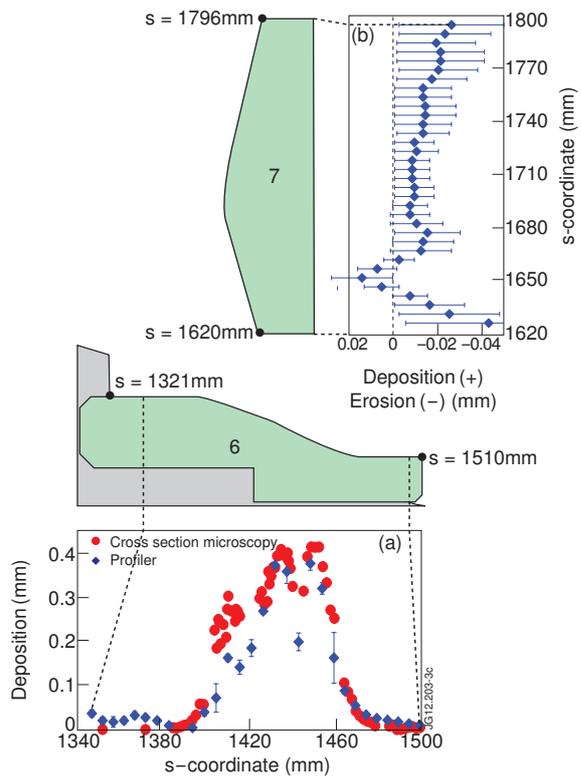
Figure 3 Profiler results for (a) Tile 6 (b) Tile 7.

Results for the total erosion, total deposition and net erosion/net deposition taking into account the number of tiles of each type found within the divertor are also shown in Table 1. Profiler results for Tiles 4, 6, 7 and the Load Bearing Tile (LBT) have been evaluated. Data for Tile 7 was for a tile installed in the vessel from 2005 - 2009 and has been scaled according to plasma time for the 2007 - 2009 operating period as for other tiles. Tiles 1, 3 and 8 have yet to be evaluated, however this will not significantly change the result as the deposition on the sloping surface of tiles 4 and 6 dominate the total amount of deposit of carbon in the divertor. For example Figure 3(a) shows deposit on Tile 6 is an order of magnitude thicker than the erosion observed on Tile 7, Figure 3(b). This is also supported by results presented in [12]. Based on the results available the net deposition onto tiles in the divertor is 533 g.

Figure 3 Profiler results for (a) Tile 6 (b) Tile 7.
